# Mariners' Alerting and Reporting Scheme

MARS Report No 320 June 2019

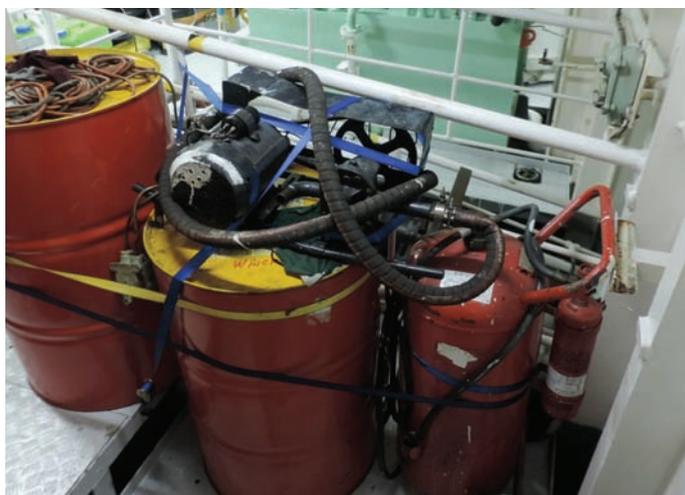
Fire extinguisher lashed and access hindered by other gear

- Are you joining a newly acquired vessel? Do the rounds and check the safety equipment.
- Keep fire-fighting equipment accessible and clear of all other gear.

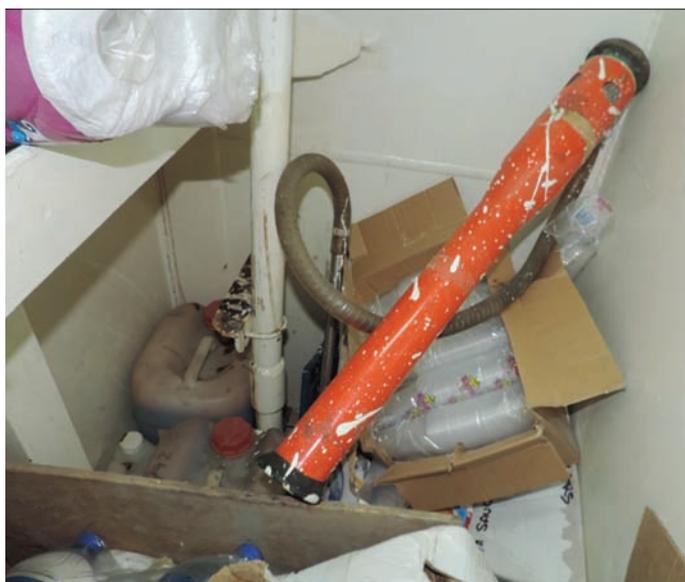
Foam nozzle stored carelessly and amongst unrelated items

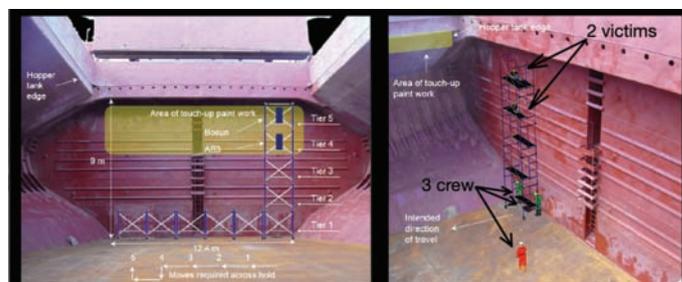
When the scaffold tower needed to be moved again, the two men stayed on the tower. The scaffold wheel brakes were released. As the three crew below moved the structure it suddenly toppled forward to the deck, taking the two men perched on tiers four and five with it.

- Some of the contributing factors listed in the official report were:
- Contrary to established procedures, two crew members remained on the unsecured scaffold tower in preparation for repositioning, rendering it top-heavy and unstable.

- The lack of formal supervision in the afternoon, plus a desire to expedite the task in difficult working conditions, probably prompted the crew members to remain unsecured on the scaffolding as it was repositioned.
- The report also identified several factors that increased risk, such as:
  - The scaffold tower had several defects that reduced its stability.
  - Guidelines for the provision, care and use of the scaffold tower were not supported by suitable onboard documentation.
  - Neither crew member on the scaffold tower made use of the required safety harness and associated safety lines, which would have prevented them falling when climbing or working on the tower.

- Where there is a strong safety culture, crew are likely to work safely, even when under their own supervision.
- Always wear fall-arrest protection when working aloft.
- Needing to get the work done is no excuse for skirting procedures.

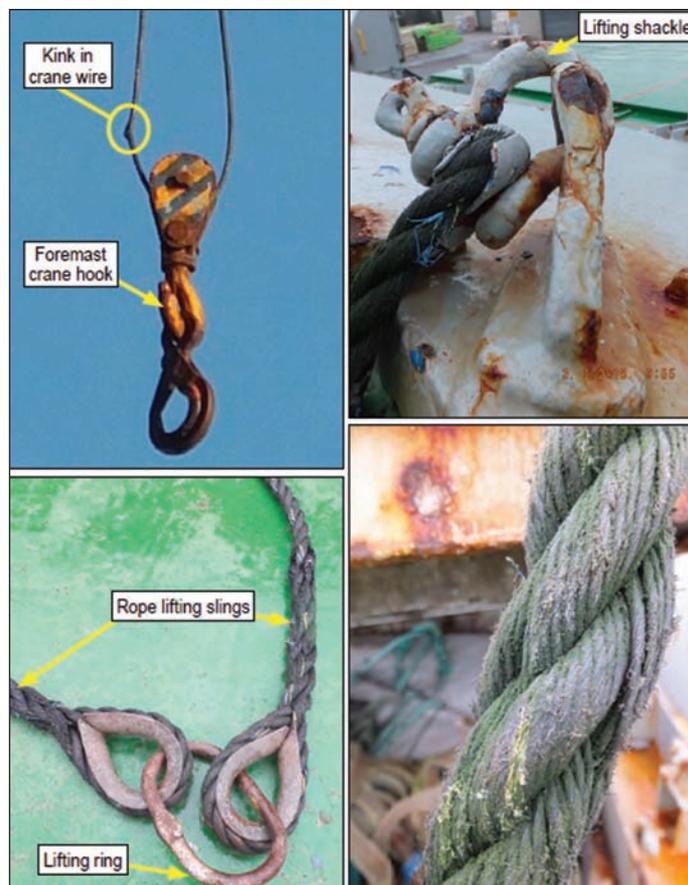
Poor SMS = poor maintenance

for opening and closing the stowage space cover had not been developed. Additionally, maintenance routines were not in place for lifting appliances.

- Identify hazards for work routines and either 'engineer out' those hazards or establish procedures to mitigate risks.
- A strong safety culture on board takes many forms. They include zero tolerance for alcohol and an awareness that tasks must be performed in a timely fashion but without undue haste. Poor maintenance, on the other hand, is often a symptom of a weak safety culture.

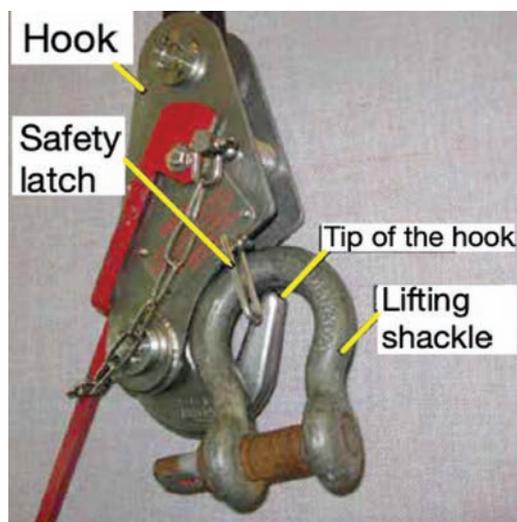
After the incident, inspection of the hook showed that the spring-loaded safety latch on the hook was bent to one side, creating a gap

Lifting shackle positioned on the tip of the hook

between the latch and the tip of the hook. It could not be determined when or how the safety latch became bent.

The investigation also determined that the hook design is such that the lifting shackle can rest on the tip of the hook. The lifting shackle may have become positioned on the tip of the hook when the falls were slack while the rescue boat was floating unmaned in the water, thus creating an opportunity for uncontrolled release.

- Whenever lifting gear is left loose but still connected, the connection should be inspected before restarting the lift.
- Good practice for boat recovery is to lift the craft just high enough out of the water to be free of waves and swell and then verify the connection before completing the lift.
- Make a point of always checking the safety latches on the hooks, if equipped. They play a crucial role in safety.
