# Mariners' Alerting and Reporting Scheme

MARS Report No 333 July 2020

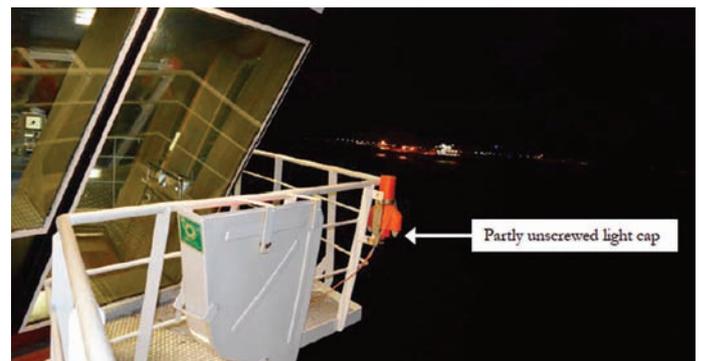
The investigation determined that the slipper that was found beside the starboard side lifebuoy release station belonged to the OOW. The other slipper was not found. The light cap on the lifebuoy was partly unscrewed. One of the light caps and two O-rings from the port side lifebuoy were found on the chart table on the port side of the bridge. The light bulb was mounted on the smoke signal and showed no sign of being defective.

The guard rail at the lifebuoy release station was 103 cm in height with two intermediate bars set at a distance of between 20 and 30 cm below. The buoy was mounted on a steel bracket by the passageway on the outside of the guard rail stanchion, which made it inconvenient to access. The only way to get a complete view of the lifebuoy was either to lean over the guard rail or to kneel on the grating to look between the intermediate bars.

The OOW was 173 cm tall, which would make it difficult for him to lean over the guard rail without stepping up on the intermediate bar. It is therefore likely that the OOW stepped on the intermediate bar and leaned over the guard rail in order to loosen the light cap to inspect the light. In doing this he most likely lost his grip and fell overboard.

The investigation found that there was no readily available way to check the functioning of the buoy without dismantling it from the bracket. The lack of instructions or guidance from the preventive maintenance system meant that the OOW had to use his own judgement to carry out this task. The OOW presumably decided to inspect the light and smoke signal in place as removing it involved a certain risk of dropping the lifebuoy overboard, particularly when working alone.

- As a matter of course, all maintenance tasks should be the subject of a risk assessment and the actions necessary for such maintenance should be documented in a procedure.
- Never work alone if there is even the slightest chance of falling overboard.
- Wearing slippers while on watch is not a best practice. Not only do they give less than adequate traction and protection, but an emergency could be declared at any time and a watchkeeper should be properly dressed and ready to respond.

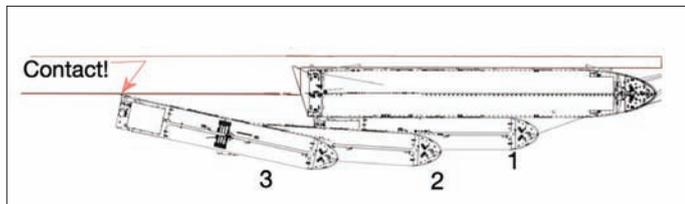
➔ A small tanker was port side to, secured alongside another larger berthed vessel (position 1). The tanker was to shift to the berth just aft of the larger vessel under the guidance of a pilot, a manoeuvre the vessel and crew had performed numerous times in the recent past. On the bridge at the time were the Master, helmsman, lookout, cadet and pilot. As the manoeuvre began, the vessel remained on the bow spring, with the rudder hard to port and the engine dead slow ahead in order to open the stern from the other vessel.

Once a gap astern was established the bow spring was released and the vessel started to go astern with the bow thruster running at 50% to starboard with engine dead slow astern and rudder midships (position 2). Suddenly, a gust of wind arose from the starboard side and the tanker’s bow was pushed towards the berthed vessel. In reaction, the bow thruster was put to full to starboard and the engine slow ahead and then half ahead with rudder 20° to starboard. However, the vessel’s stern was now too close to the pier and contact was made at about one knot (position 3).

- Use of tug?
- Allow more of a gap to develop between the vessels before coming astern?
- Less speed astern?

Hindsight is 20-20. Try and envision your manoeuvre before you undertake it, be conservative and expect the unexpected.

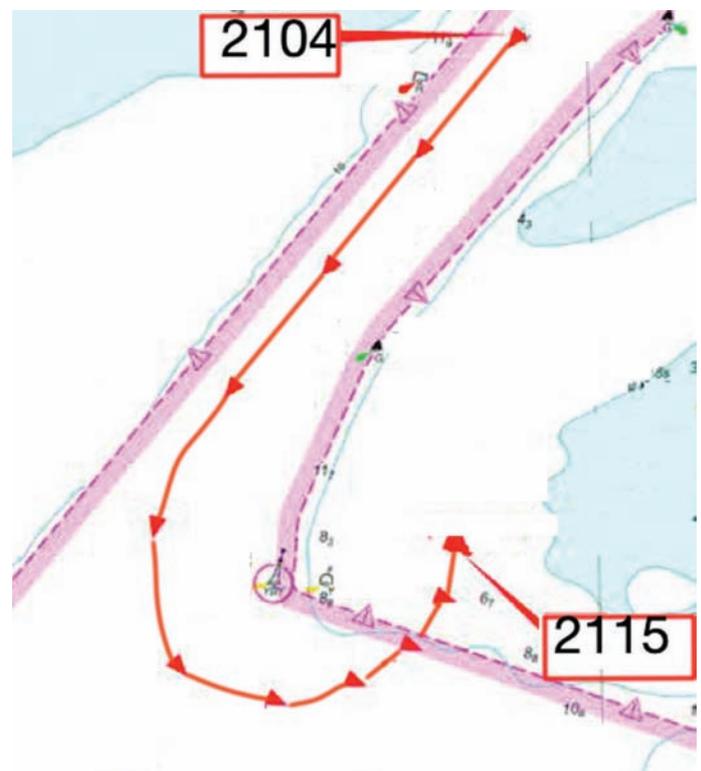
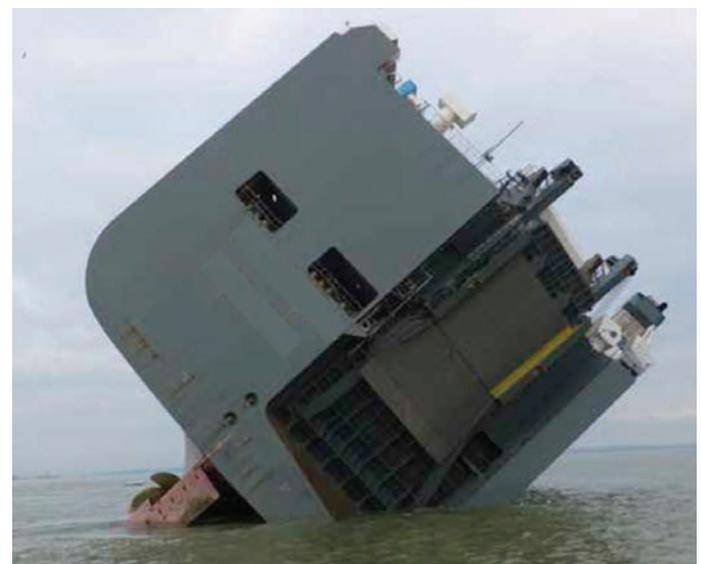
The pilot ordered 'hard a starboard' and 'stop engines'. He inquired about the vessel's GM but it was already too late. The vessel blacked out and the starboard list continued to increase as the ship swung to port and grounded, (top left) its rudder and propeller now clear of the water (bottom left). Rescue and salvage operations were subsequently undertaken.

- The vessel had inadequate residual stability to survive the port turn at 12 knots and did not comply with IMO stability requirements.
- The vessel's actual cargo weight and stowage were significantly different from the final cargo tally supplied to the ship.

- Several unsafe practices or pre-existing conditions contributed to the vessel's inadequate sailing stability, including;
  - Cargo unit vertical centres of gravity (VCGs) were not considered when calculating the stability condition;

- Ballast tank quantities were estimated and differed significantly from actual tank levels;
  - Most of the cargo weights supplied by the shipper were estimated rather than actual values. In reality, there were significant differences between the two for several cargo units;

- The investigation uncovered evidence that suggests sailing without a finalised and accurately calculated GM is a practice that extends to the car carrier sector in general.

- Without proper training it is likely that unsafe practices will become the norm.

- When unsafe practices become the norm, it is only a matter of time before an accident occurs.
