Mariners' Alerting and Reporting Scheme

MARS Report No 330 April 2020

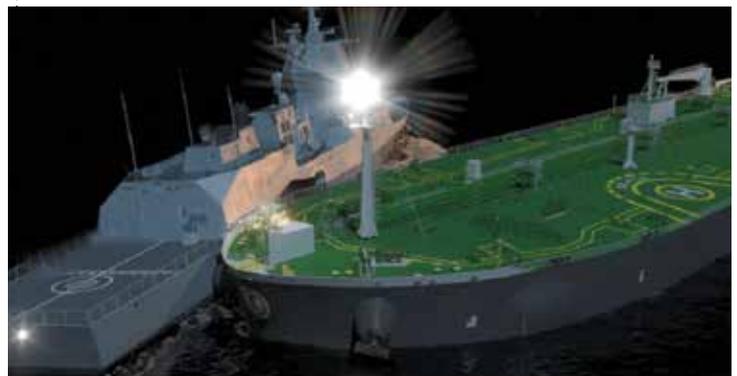
Simulated image of collision

The OOW on the frigate suddenly realised that the 'object' that was giving off light was moving and that they were on a direct collision course. Seconds later, the pilot on the tanker ordered full speed astern on the engines but the two vessels collided nonetheless. The tanker's starboard anchor ploughed into the starboard side of the frigate causing extensive damage.

2min 8 sec before collision

X Approximate position of collision

- Small course changes are to be avoided if you want to signal to an oncoming vessel, via radar and visual aspect, that you are changing course.
- Darkness and/or poor visibility changes everything. Would this have happened in daylight?
- Radar targets that are not emitting AIS signals should always be plotted.
- Never assume. Establish the facts.

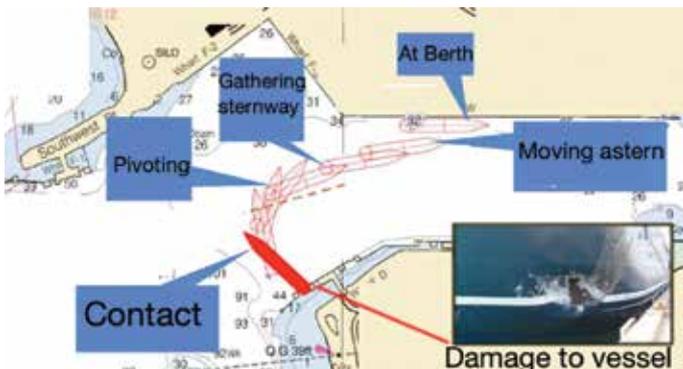
As the vessel gathered sternway, it contacted the dolphins aft. The investigation found, among other things, that the Master's abilities were probably negatively affected by alcohol consumption.

Although the major contributing factor to this accident appears to be alcohol abuse by the Master, several other factors conspired to allow the mishap. Had proper BRM been applied, the single point failure of the Master may have been avoided.

- The bridge team, including the pilot, should all be on the same page. To accomplish this a plan should be agreed and implemented and a common language used.
- Closed-loop communications are an essential part of good BRM.

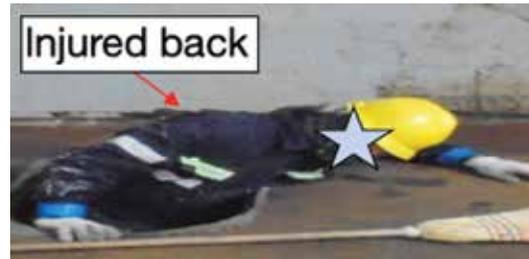
→ While at sea, deck crew were sweeping the empty hold of a vessel. The bilge well covers had been left open and were without barriers or guards. One crew member was near the bilges. Concentrating on his sweeping, he forgot that the bilge well covers had been removed. He stepped back and fell into one of the bilges. He was immediately helped out of the bilge well and given a physical evaluation. No apparent injuries were observed but the next day he complained of mild back pain. On arrival at port, he was sent to the shore doctor for further evaluation and medication.

- In this case the injuries were not severe but they might well have been. Always protect unattended open manholes with guards or barriers.
- Practise on-site risk assessment to identify all potential hazards at the work site and implement the necessary risk reduction measures.
- Stay aware of your environment – situational awareness is your best friend.

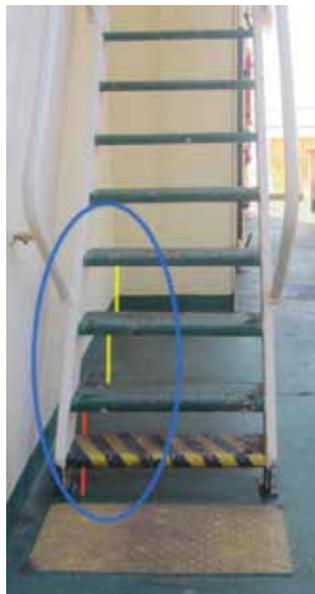
→ A visitor on a vessel almost fell as he descended the last steps of the exterior accommodation ladder. The last two treads were not equidistant from the rest of the stairs. This appeared to be an 'as built' construction issue but was clearly a tripping/fall hazard that had not yet been identified by the crew. Although the upper and lower steps of these stairs were nicely tiger-striped to identify them, the stairs themselves were not totally safe.

- As a design principle, stair treads should always be equidistant.
- We often become accustomed to hazards in plain sight; sometimes visitors are more likely to identify these than crew. Try taking a walk about on your vessel and look for hazards with 'new' eyes.
- Always have at least one hand on a railing when using stairs.

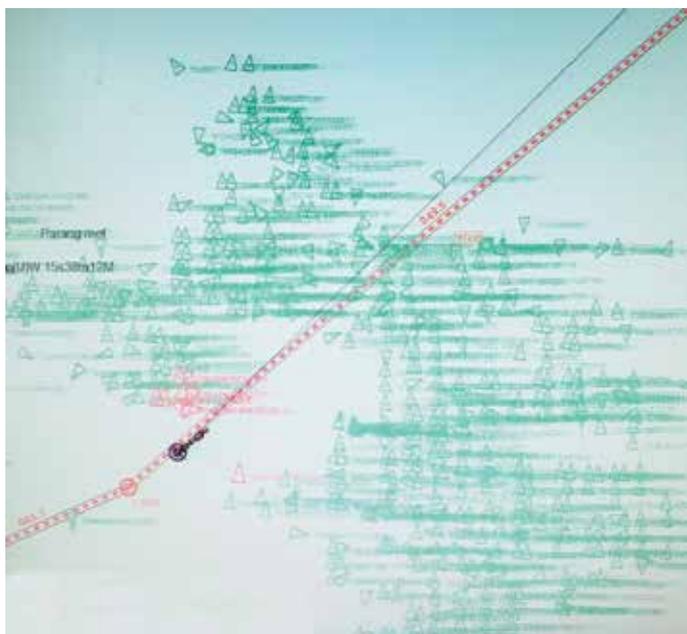
→ The AIS-equipped fishing net problem seems to be increasing exponentially. The picture below was taken on a recent trip from Shanghai to Busan showing a multitude of AIS targets, most of which are fishing nets. The vessel's recent-model AIS receiver can show up to 1,000 contacts, but still it is overloaded. It appears that these 'smart' fishing nets are now hailing ships by call sign and/or MMSI number over VHF channel 16, with an automated voice giving its bearing and position and telling vessels to keep clear. But which AIS target is it?

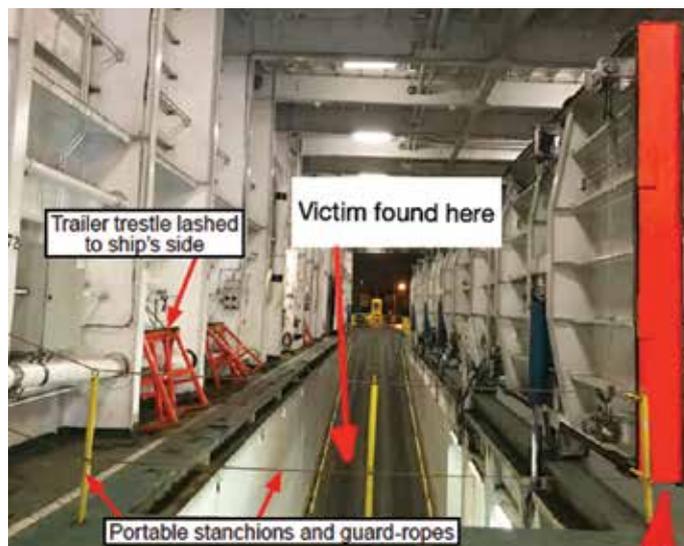
Task: Paint end of ramp hatch

→ An experienced deck crew member was tasked with painting the end of a raised car-deck ramp hatch while a ro-ro was at dock. He was attending to this work alone when several other crew heard a loud crash in the vicinity of the ramp. The other crew found the victim lying on the inboard side of the ramp, some 4.5m below the main deck, with a trestle lying on its side and across the lower part of his right leg.

- The victim crossed a safety barrier and fell 4.5m from the main deck on to the ramp.
- The victim's task did not require access to the unprotected deck edge beyond the rope barrier. It is not known why he entered the hazardous area.
- Work practices adopted by other deck ratings during hatch cover maintenance two days earlier indicated that adherence to the vessel's safety procedures was more a matter of routine and compliance than of understanding and conviction.

- Experience does not give one a free pass to short-circuit safety procedures.
