CASE STUDY FOR ONBOARD SAFETY MEETING ENGINE ROOM FIRE AND FAILURE OF FIXED FIRE FIGHTING SYSTEMS

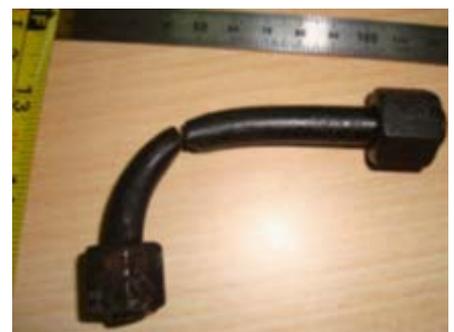
- The first fire was caused by fuel spilling onto unprotected hot surfaces from a fractured fuel pressure sensing line on the main inlet fuel supply line serving A/E2. This pipe that had been fabricated onboard and was of inferior specification. This pipe was also not properly supported from the original design and was exposed to excessive vibration leading to fatigue cracks. The maker had issued service letters notifying owners of the risk of fatigue cracks and oil spill from this pipe.
- On the cause of reignition, the report said it was either caused by the reinstatement of the fuel supply or energizing of the main switchboard once the A/E3 was started.

Locally fabricated fuel pressure line

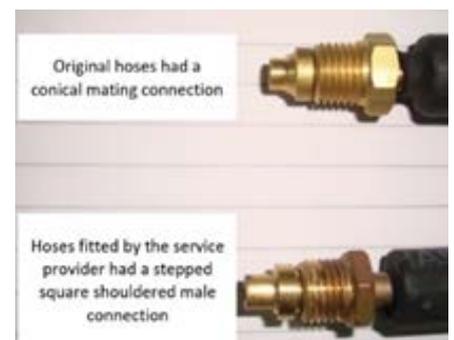
- Out of the allocated 397 cylinders, only 170 cylinders had been fully discharged.
- The fixed CO₂ system was inspected and serviced by a classification society approved third party service provider one year before the incident.
- During servicing, they changed all the flexible hoses for the pilot actuators and the discharge lines.
- The new flexible hoses had a different connection profile than the hoses installed originally, as shown in the image.
- A system pressure test was performed during the investigation, and it was noted that the new flexible hoses did not form a sufficiently robust or effective seal on the pilot air-line. Leaks were detected in all connections.

CO₂ flexible hose couplings
