Mariners' Alerting and Reporting Scheme

MARS Report No 347 September 2021

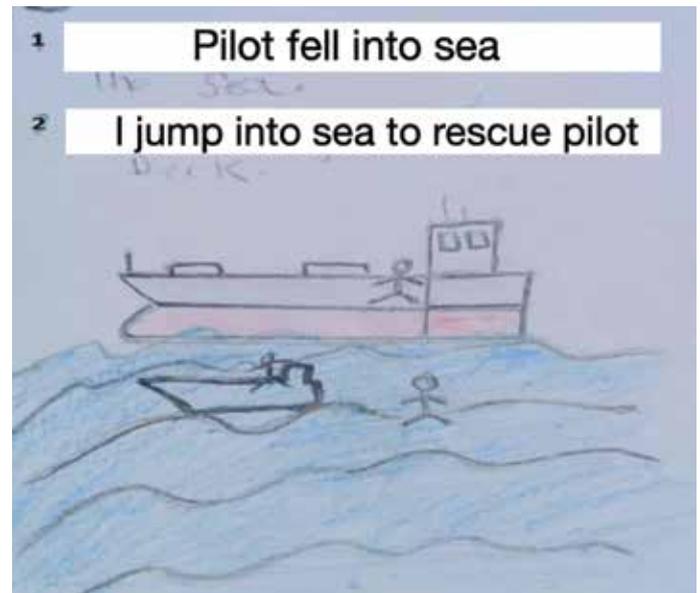
The small pilot skiff (seven metres long and one metre freeboard) came alongside and the pilot descended the ladder – about five to six metres. As he put one foot on the skiff, and the other still on the pilot ladder, the skiff moved away from ship's side due to waves. The pilot lost his balance, released his grip from the ladder and fell into the sea.

Within seconds I jumped into the sea from the upper deck. Being a good swimmer, I reached the pilot and helped support him. The ship's crew threw a life buoy as well. The pilot said he was a good swimmer too but he appreciated my help. I supported him as we swam together and we were brought on the pilot skiff within five minutes.

- Pilots and crew helping a pilot to the ladder should all wear lifejackets.
- In this case there was a happy ending. But resist the urge to jump into the water even if you have a lifejacket. It could then cause two victims.
- What is your plan if a person falls into the water from the pilot ladder?

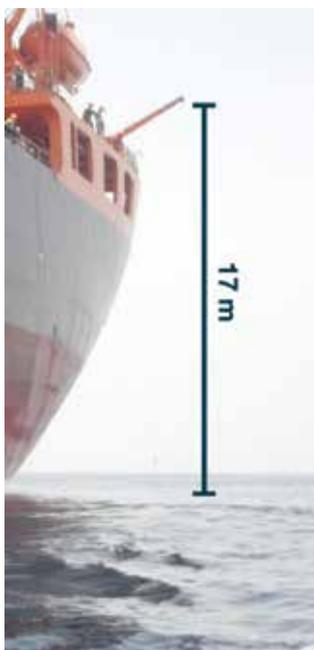
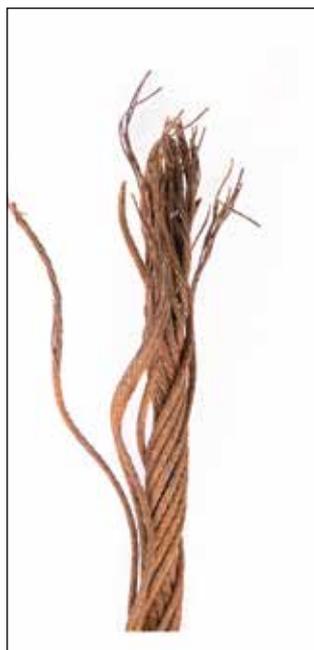
→ In calm seas a vessel was stopped while underway to allow crew to undertake boat drills. While the lifeboats were tested, the rescue boat was launched and manoeuvred close to the ship by a three person crew. The rescue boat trials lasted for about an hour before the crew brought the boat alongside for recovery. Once the hook and painter line were fastened, the crew in the boat sat on the floor in a stable manner and the hoist was started. When the boat reached the boat deck, the winch was stopped. Suddenly, the wire failed and the boat fell 17 metres, hitting the water upright. The engine was torn off its foundation, the

bottom hull cracked, and the boat slowly drifted alongside the ship's port side. All three crew members were still in the boat, but seriously injured. The alarm was immediately raised.

The official report found that the rescue boat davit's wire rope parted because it was corroded to the extent that its load bearing capacity was exceeded when the rescue boat was hoisted. However, the parting of the wire rope was an 'accident event' which could not in itself explain why the rescue boat system failed. Even though the company's Planned Maintenance System (PMS) instructed the officers to inspect and maintain the wire rope, they did not act upon the deteriorating condition of the wire rope. Neither did any of the other officers who continuously inspected, maintained and operated the rescue boat system even when the wire rope was readily visible.

The reason the poor condition of the wire rope was not recognised earlier was a combination of at least three factors:

1. The manufacturer's manual and PMS did not specify how to assess the condition of the wire rope.
2. An absence of training in assessing the wire rope's condition.
3. The PMS activities were compartmentalised. This meant that in practice only one person was assessing each component. All these factors were compounded by the thorough examination performed by service providers which gave the officers a blind trust in the system as a whole.

- Assessing the viability of a wire rope is not an intuitive process. Some wire rope may appear good but be unsafe while others may appear outwardly poor but still be very good. Special training is needed to properly inspect wire rope.
- A wire rope inspection checklist should be used for this task and the checklist should have viability criteria listed as a reminder for the person doing the inspection.
