## Case study for onboard safety meeting

# Grounding incident

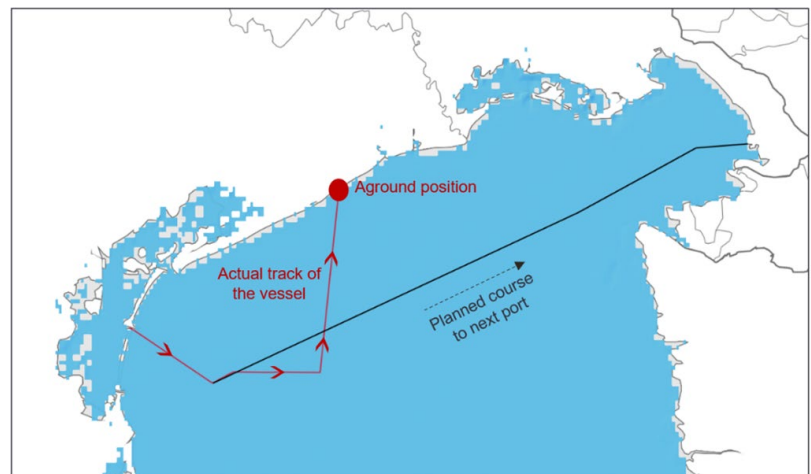
A general cargo vessel departed from port on 3 June at 0230 hrs LT with drafts of 9.0 m forward and 9.6m aft. The vessel had a very busy port schedule with stores arriving towards the end. In addition, all deck crew were heavily involved in checking cargo lashings prior to departure. The pilot departed at 0345 hrs and soon afterwards the vessel commenced the sea passage with the engines at full ahead. By 0410, she was doing a speed of 11 knots. The bridge was manned by the Master, Chief Officer and a helmsman. At 0420, the vessel was put on auto pilot and the Master handed over the con to the Chief Officer. Traffic was light with a few small boats showing on the radar and the weather was calm with clear skies and good visibility. The Master stayed on the bridge for some time and headed down to his cabin at 0435 to send some e-mails. The AB was sent down for a few jobs by the Chief Officer at 0500. Sunrise was expected in under an hour.

At 0510 the Chief Officer altered the course to starboard to avoid a fishing boat and at 0520 he set the course in a northerly direction to come back to the planned track. He started filling in the logbook and planned the day work for the deck crew. He then shifted his focus to cargo related paperwork which the managers and charterers required the vessel to complete soon after departure from each port and to be sent to them by email. The vessel's course was not changed once it was back on the planned track and she continued in a northerly direction. The vessel ran aground at 0640. Two tugs had to be called to tow the vessel to a safe anchorage. The authorities and port state control also boarded the vessel for investigation.

- Interview with other crew members revealed that the chief officer was probably fatigued, both physically and mentally, due to a busy schedule in port, although his work and rest hours did not indicate so. There was a suspicion that he fell asleep on bridge, but this could not be confirmed.
- The Bridge Navigation Watch Alarm System (BNWAS) was not turned on.
- All alarms on ECDIS, such as for off-track and anti-grounding were muted and hence there was no audible alarm to alert the Chief Officer of the vessel's deviation.
- There was no lookout on the bridge.

- No paperwork to be done on the bridge.
- Lookout cannot be sent down from the bridge in periods of darkness and reduced visibility.
- Both audible and visual alarms on equipment such as ECDIS, GPS and Radar are to be kept 'on' when underway or at anchor.
- Ensure that BNWAS is kept on and in the correct mode. An additional point to reflect this was also included in the pre-departure checklist.
- The watchkeeper keeping the first bridge watch after departure must be well rested.
- Master given the liberty in SMS to delay departure or anchor after departure to give the crew sufficient rest.
- Crew encouraged to inform shore management if rest hours cannot be complied with and if additional resources are needed.
