# SAFETY ALERT

**Safety Alert No. 353**  
**4 June 2019**

## Offshore Employees Fall Through Grating and Open Hole

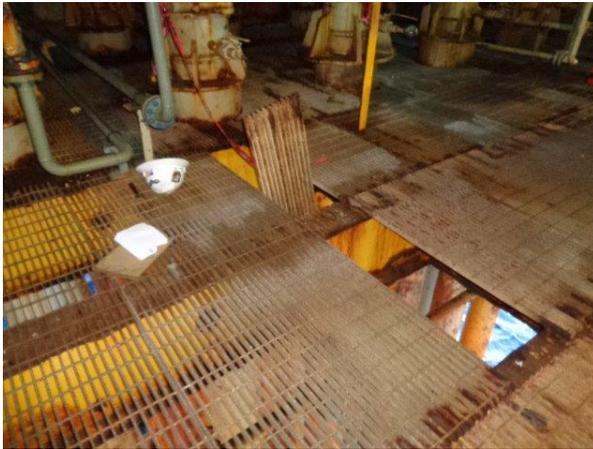
*Incident site at EI 331 B – photo taken May 29<sup>th</sup>*

Recently at Eugene Island Block 331, Platform “B,” a night-time production operator on a fixed facility was identified as missing from the platform during morning rounds. The personnel onboard noticed a section of grating displaced in the upright position with the missing person’s hardhat and clipboard next to the grating in the wellbay deck. The open hole measured approximately 93-inches long by 13-1/2 inches wide and was approximately 45 feet to the water’s surface. Preliminary information indicates that prior to the incident the wellbay deck area was taped off with red “DANGER” tape, but the area was not hard barricaded to prevent flow of personnel.

- Review this Safety Alert with your crew and discuss hazardous areas and encourage feedback to ensure understanding.
- Conduct a review on the integrity of decks, grating, and structural and support beams on your facility. If an area of marginal or suspect strength is identified, ensure that it is clearly marked, appropriate mitigation actions are taken, and employees are informed of those zones.

- Conduct a review of your facility to identify any open holes or surfaces that are not capable of supporting personnel and, if such an area or open hole is identified, ensure that it has been properly barricaded and/or covered.

- Conduct a review of your facility to confirm that all grating and flooring sections are securely fastened to the underlying structural members. Access should be prevented to areas where the grating and flooring sections are not securely fastened to the underlying structural members or barricaded as described below.

- To prevent the flow of personnel into hazardous areas, verify all barricades:
  - have a top rail and middle rail;
  - are at least 42 inches in height and capable of withstanding a load of at least 200 lbs. applied in any direction.

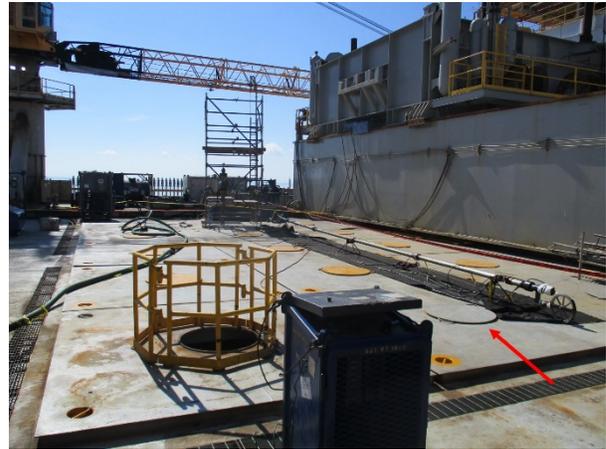
*Incident site at GC 205 A – photo taken June 2<sup>nd</sup>*

A second incident took place at Green Canyon Block 205 “A”. A wireline crew had completed work on a well which was properly barricaded. At approximately 2300 hours, two employees went to replace the well access hatch cover over the well on the drill deck. Preliminary information indicates that each of the two employees inadvertently picked up the wrong hatch cover (identified in the photograph above with a red arrow). Each employee grabbed one handle of the cover, which was the same color as the deck and had no well identifying information on it. This action unknowingly created an open hole; and as the employees moved the hatch, one of the employees stepped and fell through the hole to the deck below – approximately 90 feet.

- If an open hole is found that cannot be immediately barricaded as described above, identify an Open Hole Attendant / Hole Watch, with no other duties – and ensure that the person is equipped with adequate fall protection at all times.
