## Chittagong, Bangladesh – risk of collision and grounding

### Background

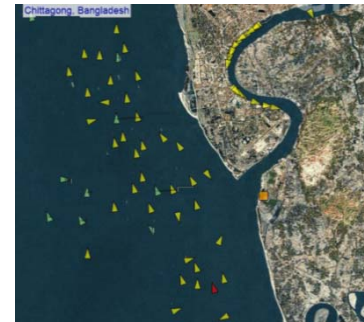
With the Patenga light beacon bearing more than 055°, the seabed is soft mud and vessels are liable to drag anchor. With the Patenga light beacon bearing less than 055°, the holding ground is relatively firm but attention must be paid to the strength of the ebb tide<sup>1</sup>, especially during the monsoon months (normally June to November).
