# Pilotage

A selection of articles previously published by Gard AS

# Contents

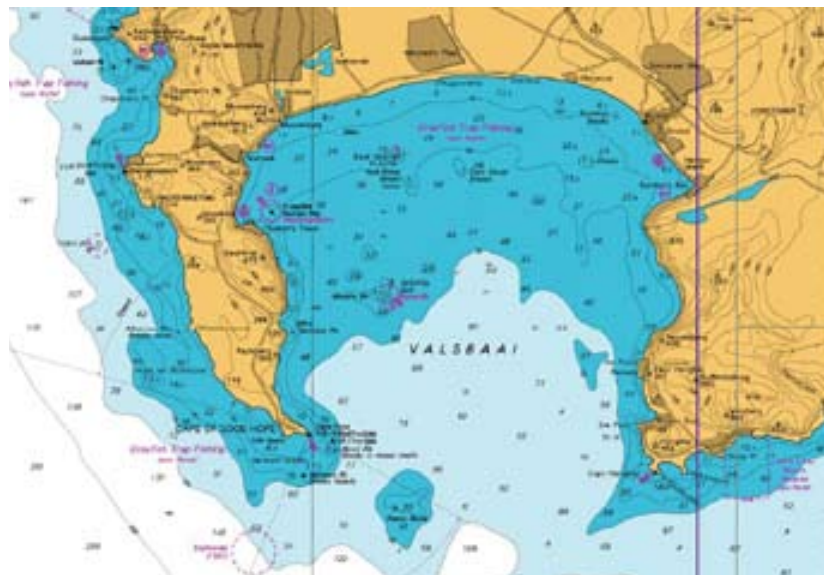
Nautical chart of Valsbaai (False Bay).

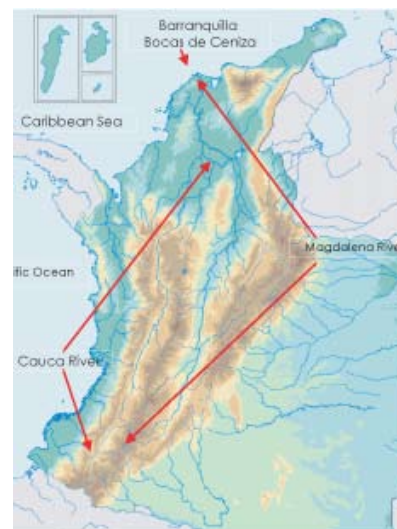
Figure 1- Magdalena River & Rio Cauca reaches the sea in Barranquilla

There are currently unusually large volumes of water in the rivers, and special directional dams at Bocas de Ceniza have been constructed to accelerate the flow of the river to maintain and improve depth and thus the draught for the shipping channel. This has created unprecedented conditions and increased the risks involved in navigating in the port of Barranquilla.
